TECHNICAL

Settings using detonation counters

RS125R / RS250R

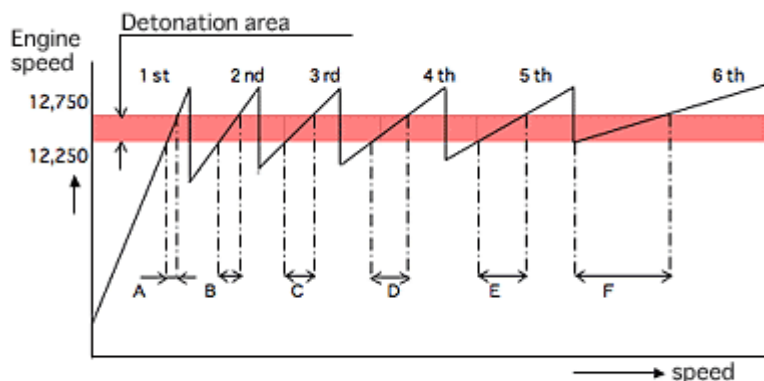
fig. Detonation area

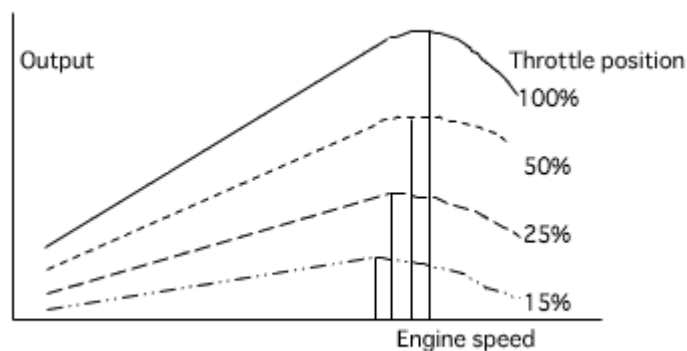
fig. Detonation area

In the engine output characteristics figure shown above, peak speed are changing, depending on wide open throttle to partial throttle. Accordingly, detonation occurrence ranges may vary with throttle opening. Detonation may suddenly take place when returning throttle from fully wide-open throttle at 11000 rpm.
